**Flood Control Project Maintenance
Levee Inspections**

Fall 2016 Levee Maintenance Deficiency Summary Report

Sacramento Maintenance Yard East Levee Yolo Bypass

Levee Inspection Report By Mile - Fall 2016

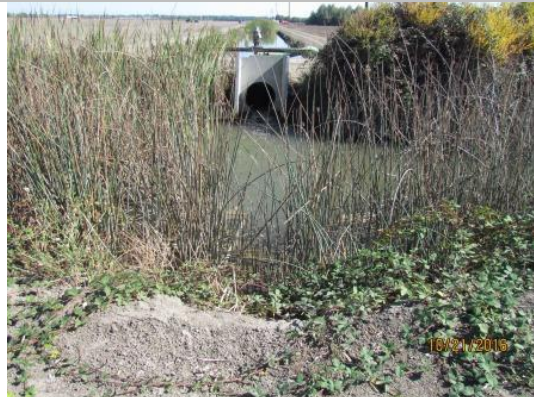
Photo 2 of 2 : FA_2016_ST0004_41_1_20161025_00004.jpg

LM Start	1.51	Rating **	M	Issue No.	1 (cont)	
LM End	1.51	Issue Type +	Ob	Location *	LS	
Category	Earthen Levee			GPS Latitude/Longitude		
				Start		End
Item	Erosion / Bank Caving			38.743573 °	38.743573 °	
				-121.634128 °	-121.634128 °	
DWR ID	DWR_ST0004_01_f_2016_1					
Comment Code						
E1 : Note and monitor erosion site.						
Inspector Comment						
Erosion on a side of a ditch toward LS toe caused by water coming out of irrigation canal.

Irrigation ditch erosion caused by water flowing from perpendicular irrigation canal. Fall 2016.

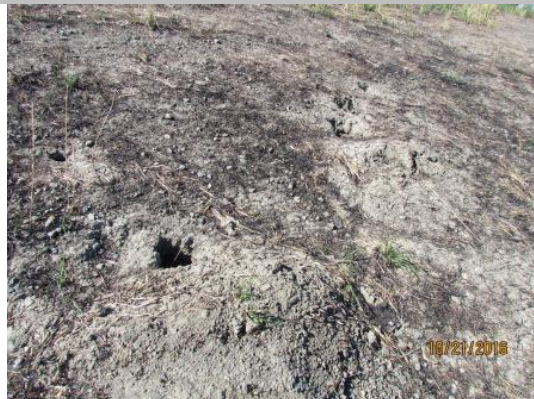
Photo 1 of 2 : FA_2016_ST0004_41_6_20161025_00005.jpg

LM Start	1.65	Rating **	M	Issue No.	6
LM End	1.65	Issue Type +	Ma	Location *	LS
Category	Earthen Levee			GPS Latitude/Longitude	
				Start	End
Item	Animal Control			38.741579 °	38.741579 °
				-121.634007 °	-121.634007 °
DWR ID	DWR_ST0004_01_f_2015_6				
Comment Code					
A3 : No rodents visible, but rodent burrows visible; need to backfill and compact or grout burrows.					
Inspector Comment

Updated view of rodent holes at this site. Fall 2016.

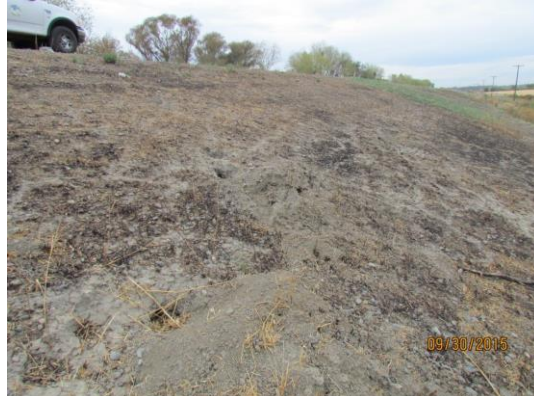
Photo 2 of 2 : FA_2016_ST0004_41_6_20160913_00001.jpg

View of the rodent holes on the landward side of the levee looking upstream. Fall 2015.
